Manhole Inspection Summary

Manhole # S17001017MH

Insp Date: **11/30/07 10:19 AM**

Location Address: **TAMARIND RD**

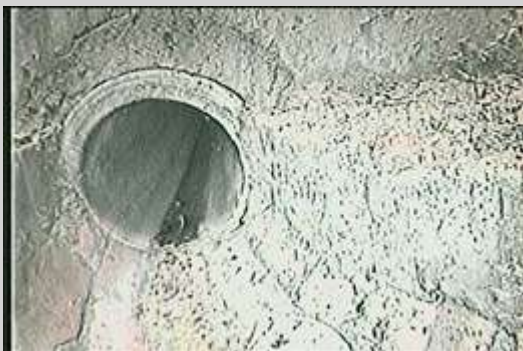
8 in. Circular Gravity Sewer Pipe In @ 9 O'Clock

Rod and Bar (Angled)

Infiltration: **None** Pipe Seal Cond: **Unknown**
